Mapped, edited, and published by the Geological Survey
Control by USGS and USC&GSTopography from aerial photographs by photogrammetric methods
Aerial photographs taken 1951. Field check 1960Polyconic projection. 1927 North American datum
10,000-foot grid based on Tennessee coordinate system
1000 meter Universal Transverse Mercator grid ticks,
zone 16, shown in blue

This report is preliminary and has not
been reviewed for conformity with U.S.
Geological Survey editorial standards.

Barman, Keith R., 1969
Geologic map of the Welchland quadrangle, Tennessee.
Tennessee Department of Conservation,
Division of Geology, scale 1:24,000.LANDSLIDES AND RELATED FEATURES
OF THE WELCHLAND, TENN. QUADRANGLEby
Roger E. Thomas
1981U.S. Geological Survey
OPEN FILE MAP 81-1318 (F-4)

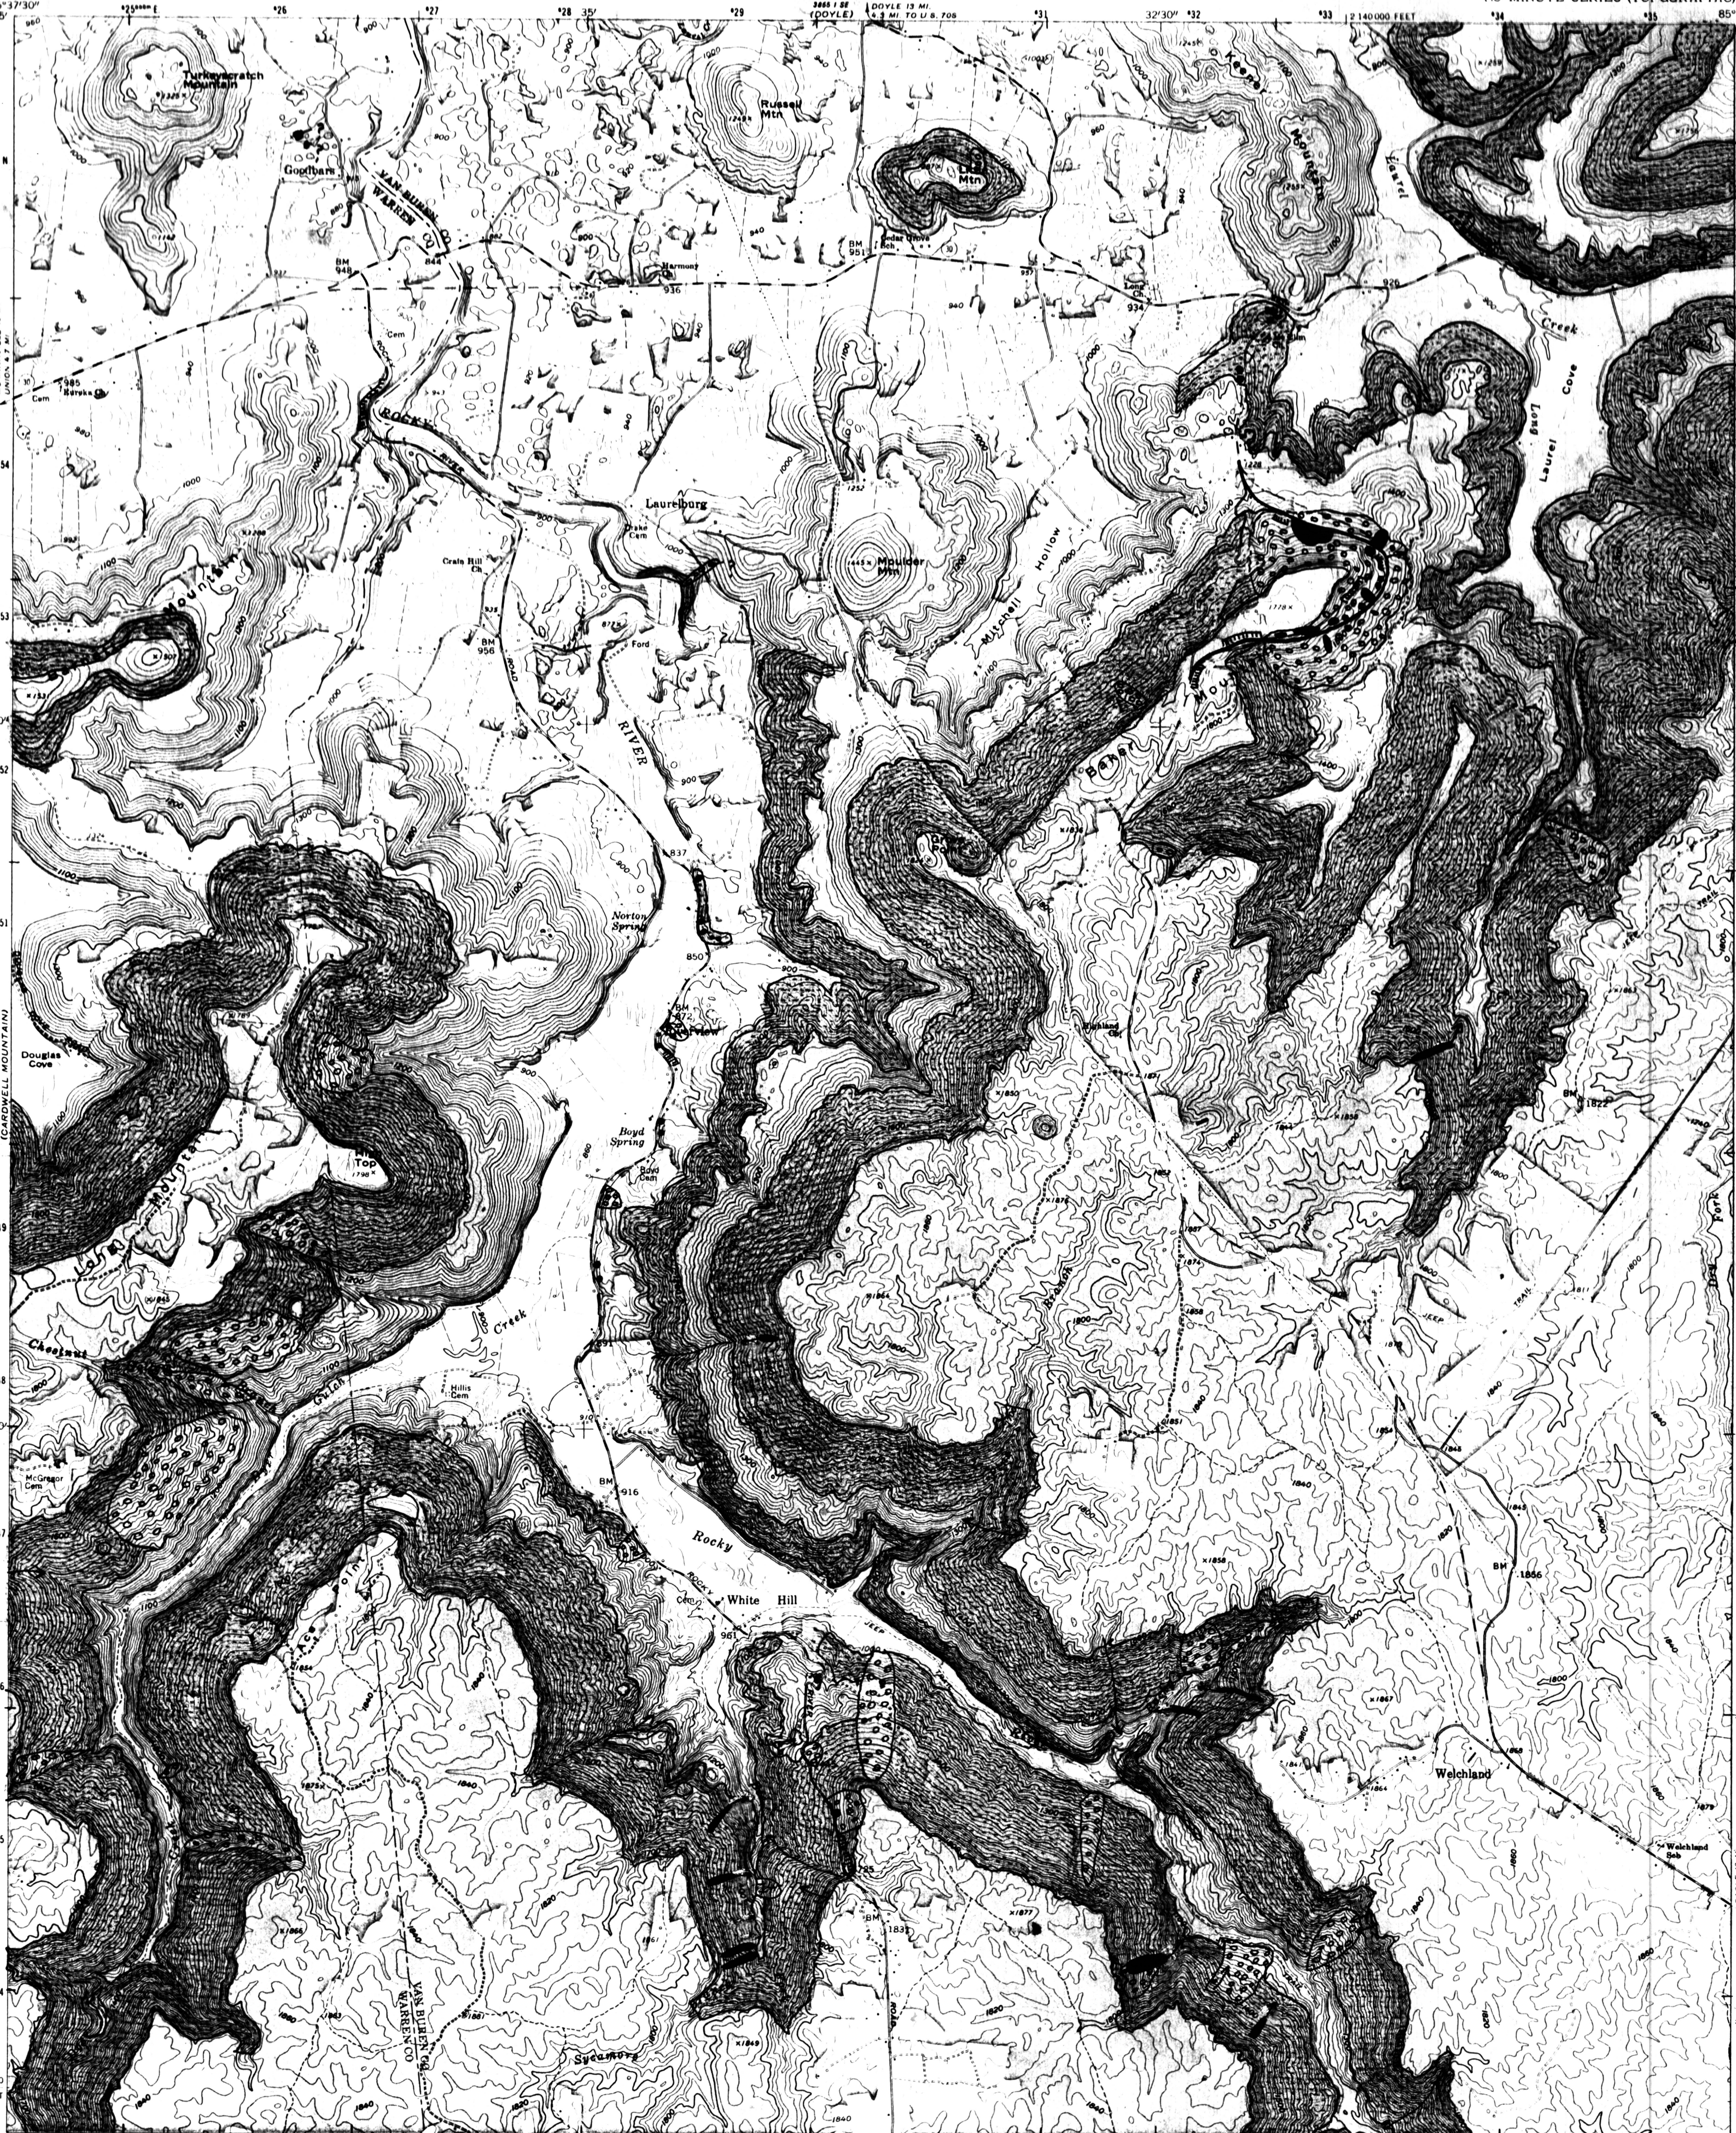
ACTIVE OR RECENTLY ACTIVE LANDSLIDE

Complex landslide composed of earthflow, debris
slide, earth and rock slump. Identified from
historical records, and from scars, debris and
other field evidence. Ground extremely unstable;
sliding accelerated by excavation, loading and
changes in drainage conditions. May include
areas with several active slides too small to
be shown separately. Questioned where doubtful.

OLD LANDSLIDE

Area of extensive hummocky ground caused by
earthflow and earth and rock slump. Lacks
clear evidence of active sliding. Relatively
stable in natural, undisturbed state,
generally not affected by small structures properly
sited in areas away from the edge of the toe;
can be reactivated by extensive, rapid exca-
vation, loading, and changes in ground water and
surface water conditions. Area of old landslide
probably includes recent ones not identified
from field evidence or otherwise documented.
Upslope boundary of landslide generally defined
by modified scarp, but downslope (toe) may be
gradational and not well defined. Questioned
where doubtful.

COMBINATION LANDSLIDE

Area of recent and old slides in which
individual slides are not identified.

COLLUVIAL SLOPE

Valley wall along major streams with slope as
steep as 40 (85%); stony, clayey silt soil up
to 50 ft. (15 m) thick; commonly buttressed by
a terrace or bench at the toe of the slope; very
susceptible to sliding by cutting of toe area,
removal of terrace or bench, and overloading;
slide commonly activated without apparent cause.

COLLUVIAL SLOPES WITH LANDSLIDES

Landslides too small or obscure to map
individually.

AREAS SUSCEPTIBLE TO DEBRIS FLOWS AND DEBRIS
AVALANCHESPrimarily shallow, narrow ravines and chutes with
accumulation of stony colluvium generally 10 ft.
(3 m) or less in thickness; susceptible to rapid
movement during intense rainfall. Most ravines
and chutes designated show evidence of former
debris flows and avalanches.

AREAS SUSCEPTIBLE TO ROCKFALL

Steep, locally vertical, natural and man-made
slopes and cliffs, 15 ft. (4.5 m) or more high;
formed dominantly of sandstone, limestone, sandy
shale, mudstone and claystone. Interbedded mud-
stone, claystone and shale weather rapidly leaving
sandstone and limestone rock faces unsupported.

SOIL AND ROCK SUSCEPTIBLE TO LANDSLIDING

Soil and rock similar to that involved in land-
slides elsewhere in map area; primarily areas
underlain by claystone, mudstone and shale
associated with other rock types. Rock weathers
rapidly on exposure forming clayey soil highly
susceptible to sliding. Includes coves (U-shaped,
shallow valleys) containing thick layers of clayey
soil that are very susceptible to sliding where
excavation breaks continuity of slope and where
overloaded by artificial fill.

AREAS LEAST PRONE TO LANDSLIDES

Map areas in which no patterns or symbols are shown;
primarily valley floors, ridge tops and broad
benches; modification by excavation and fill may
lead to local landslides.The first six digits of the open file number designate the
specific 1:250,000 scale map sheet of which this quadrangle
is a part. The last two digits designate the position of the
quadrangle in a subdivision of the 1:250,000 scale map based
on rows and tiers shown in the diagram to the right. The
location of this quadrangle is shown by the black square.

Information shown is intended as a
general guide to ground conditions as of
the date of field check. Additional
landslides and rockfalls should be anticipated
in all map units. The map unit depicts
the dominant condition in the area delineated
and variations in slope stability may occur
at any point in the unit. This map is suit-
able for general planning purposes and as a
supplement to more detailed studies for site
selection. The map cannot be used as a sub-
stitute for detailed geologic and engineering
investigations to establish design and
construction criteria of specific sites.
Some symbols may not appear on this map
because the description is applicable to a
series of maps.

Strip mines (combination of letter symbols
indicates complex formed or more than one
type of strip mine)sh bench with high wall
sf furrowed with high wall
sd multiple furrows and multiple benches
ss hilltop removed
arg reclaimed by grading
str reclaimed by secondary use
sh/r regraded in part, high wall remainsCoal refuse banks
r identified on aerial photographs;
not classified in field checkrb not burnt nor on fire
rbb burnt
rbd burning
rbs sludge
